INSPECTION REPORT AND VALUATION

“THE BOAT”

Date of Inspection: 23rd June 2023

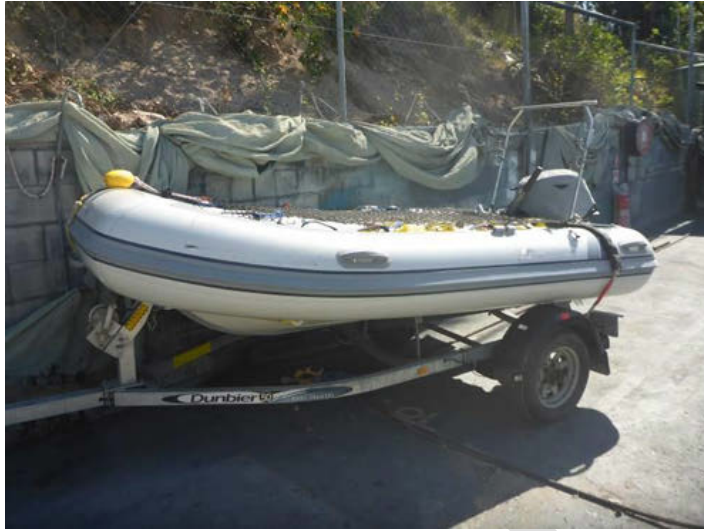
The vessel has a new tender in excellent condition

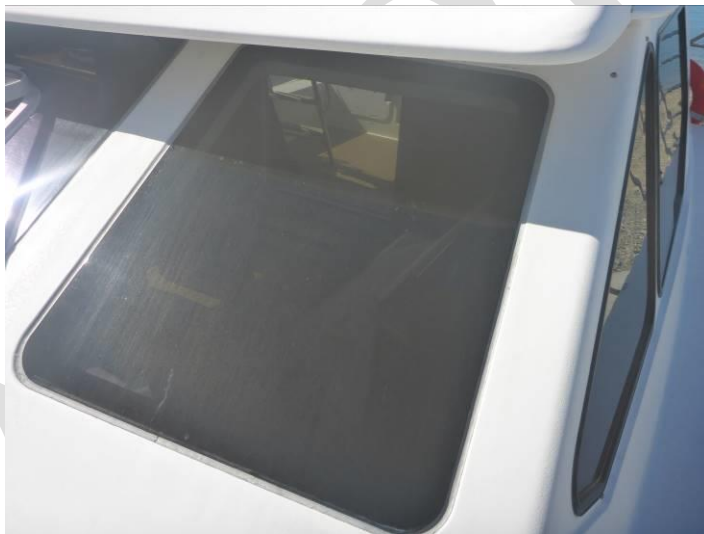
Windows and glazing dry on the inside and in reasonable condition

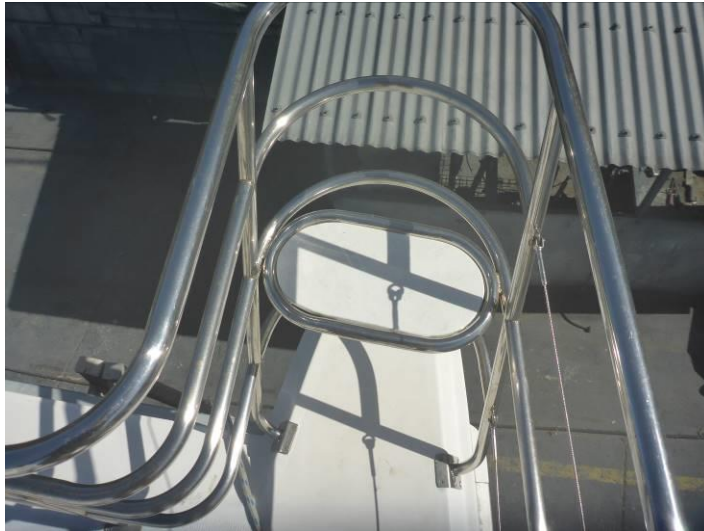
Stainless steel work presents well considering age and service

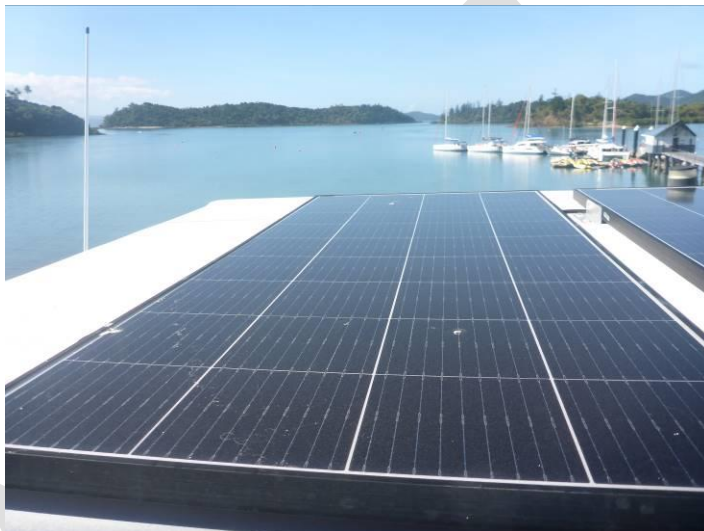
New solar installation will assist battery management

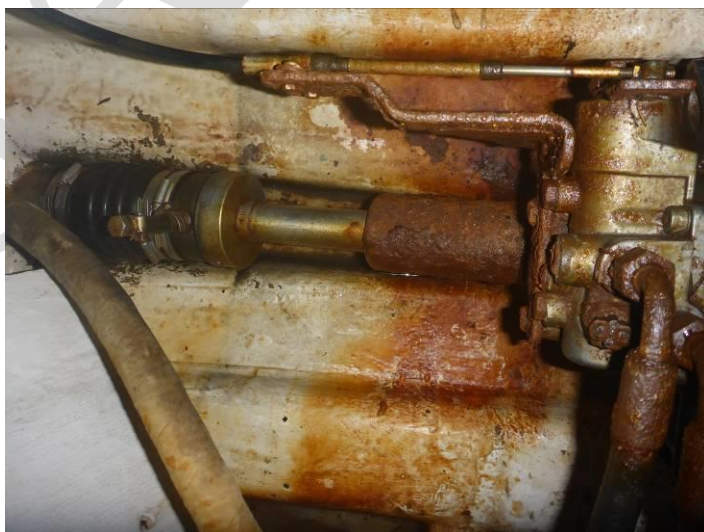
- The engine rooms could use cleaning but are not oily and overall the vessel does not smell.
- The vessel was only viewed out of the water and as such the engines were not observed running however oil sampled from the dipsticks appeared clean. The engines have relatively low hours and appear tidy.

Engine rooms would benefit from some cleaning and couplings require treatment / paint

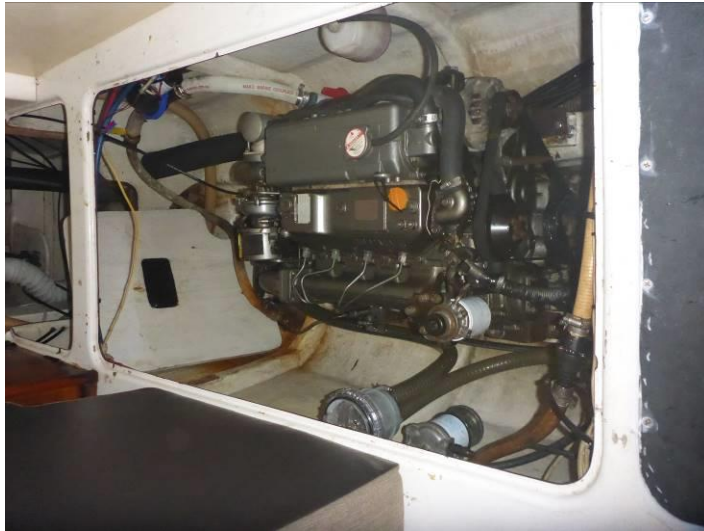
Overall engine installations are tidy and appropriate

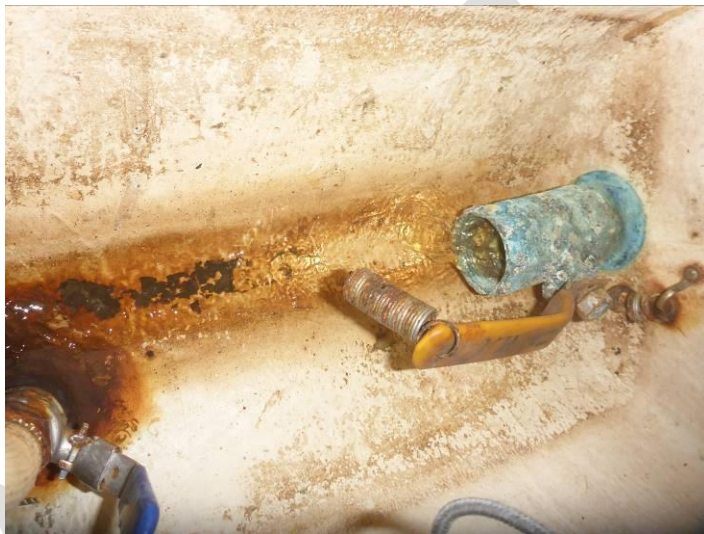
- The port rudder stock has some wear on the tiller and may require a new keyway. This is not urgent and poses no immediate threat to the vessel but should be addressed.
- The starboard tiller bolt connecting the tiller to the ram joint is loose and requires tightening
- There is one small blister on the inside of the starboard keel (about 20mm diameter). This is for information only and can be monitored at future slipping's.
- The antifouling is reasonably heavy and would benefit from grit blasting in the future.
- Small amounts of brackish water were drained from both forepeaks. The valves had not been swung in some time so I suggest there is no major leak but should be monitored.

Forepeak valves should be swung regularly and checked for water.

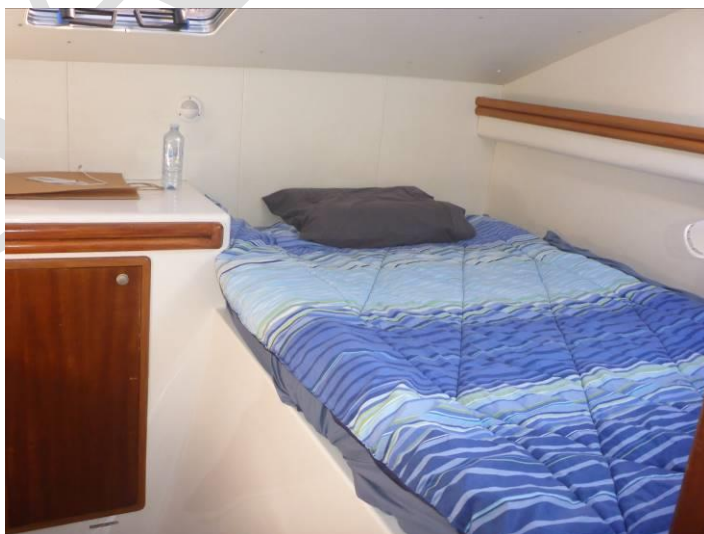
Interior is generally tidy

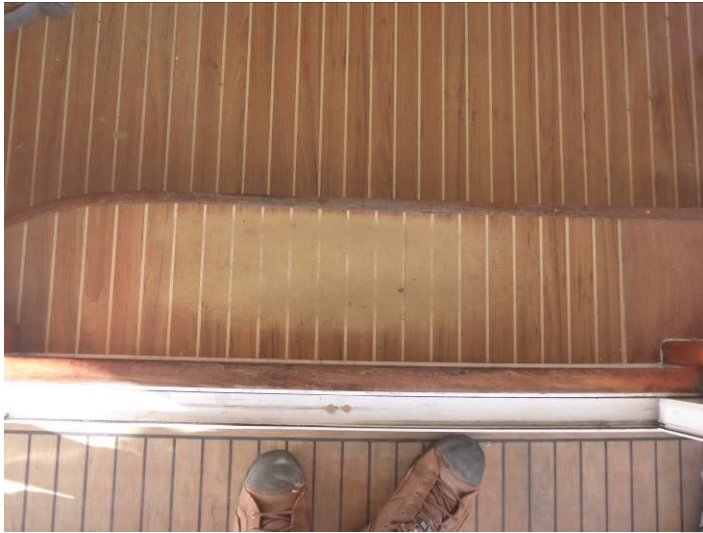
- The timber interior trim and cabin sole is showing its age and would benefit from some attention.
- Operationally, the vessel appears in condition fit to continue in its present service.

Some areas of the interior showing age and wear
